AttachmentEMapandDrawings

State of Alaska

# AVCP Tribal Region

# Newtok Shoreline Erosion

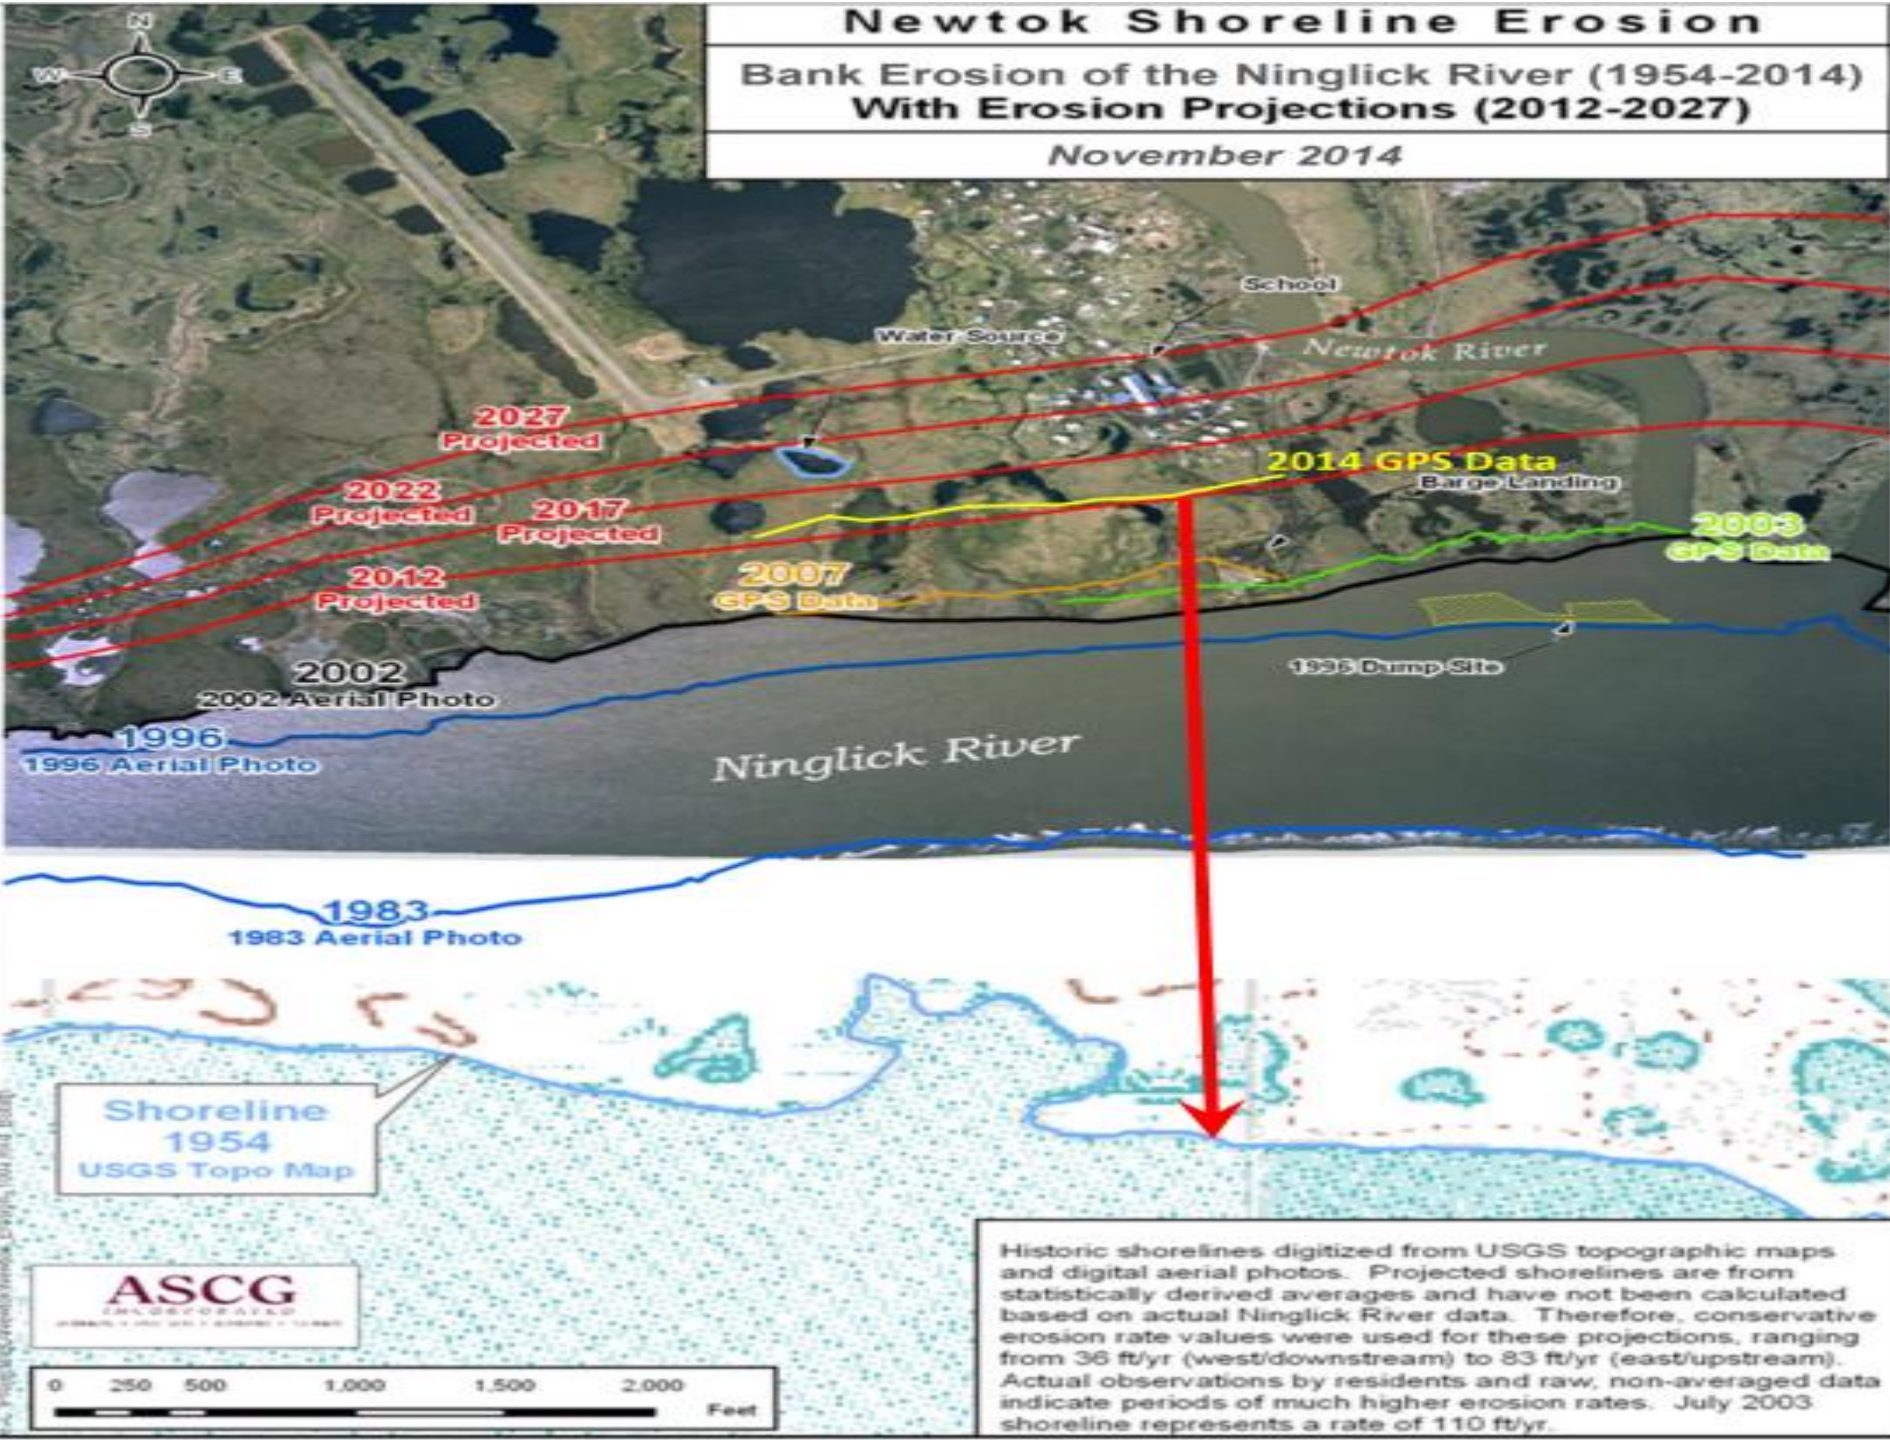
## Bank Erosion of the Ninglick River (1954-2014) With Erosion Projections (2012-2027)

Historic shorelines digitized from USGS topographic maps and digital aerial photos. Projected shorelines are from statistically derived averages and have not been calculated based on actual Ninglick River data. Therefore, conservative erosion rate values were used for these projections, ranging from 36 ft/yr (west/downstream) to 83 ft/yr (east/upstream). Actual observations by residents and raw, non-averaged data indicate periods of much higher erosion rates. July 2003 shoreline represents a rate of 110 ft/yr.

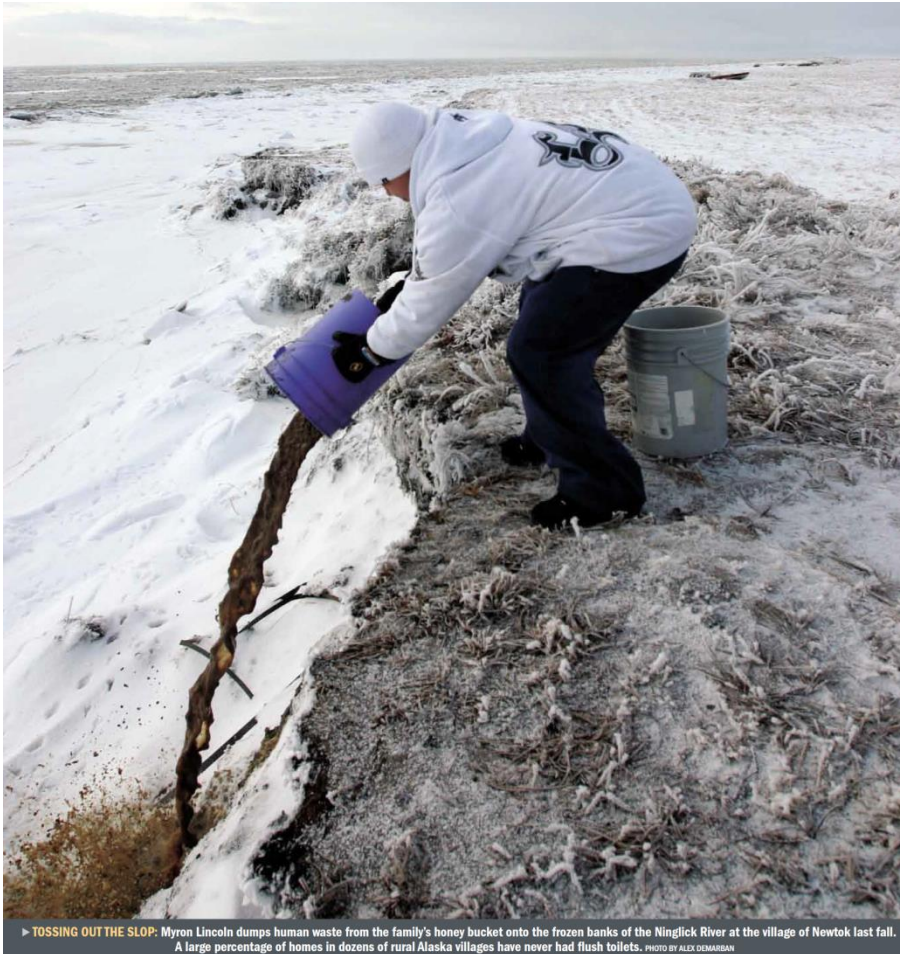
► **TOSSING OUT THE SLOP:** Myron Lincoln dumps human waste from the family's honey bucket onto the frozen banks of the Ninglick River at the village of Newtok last fall. A large percentage of homes in dozens of rural Alaska villages have never had flush toilets. PHOTO BY ALEX DEMARBAIN

Newtok resident emptying their honey bucket in the Ninglick River. Newtok has no running water or flush toilets.

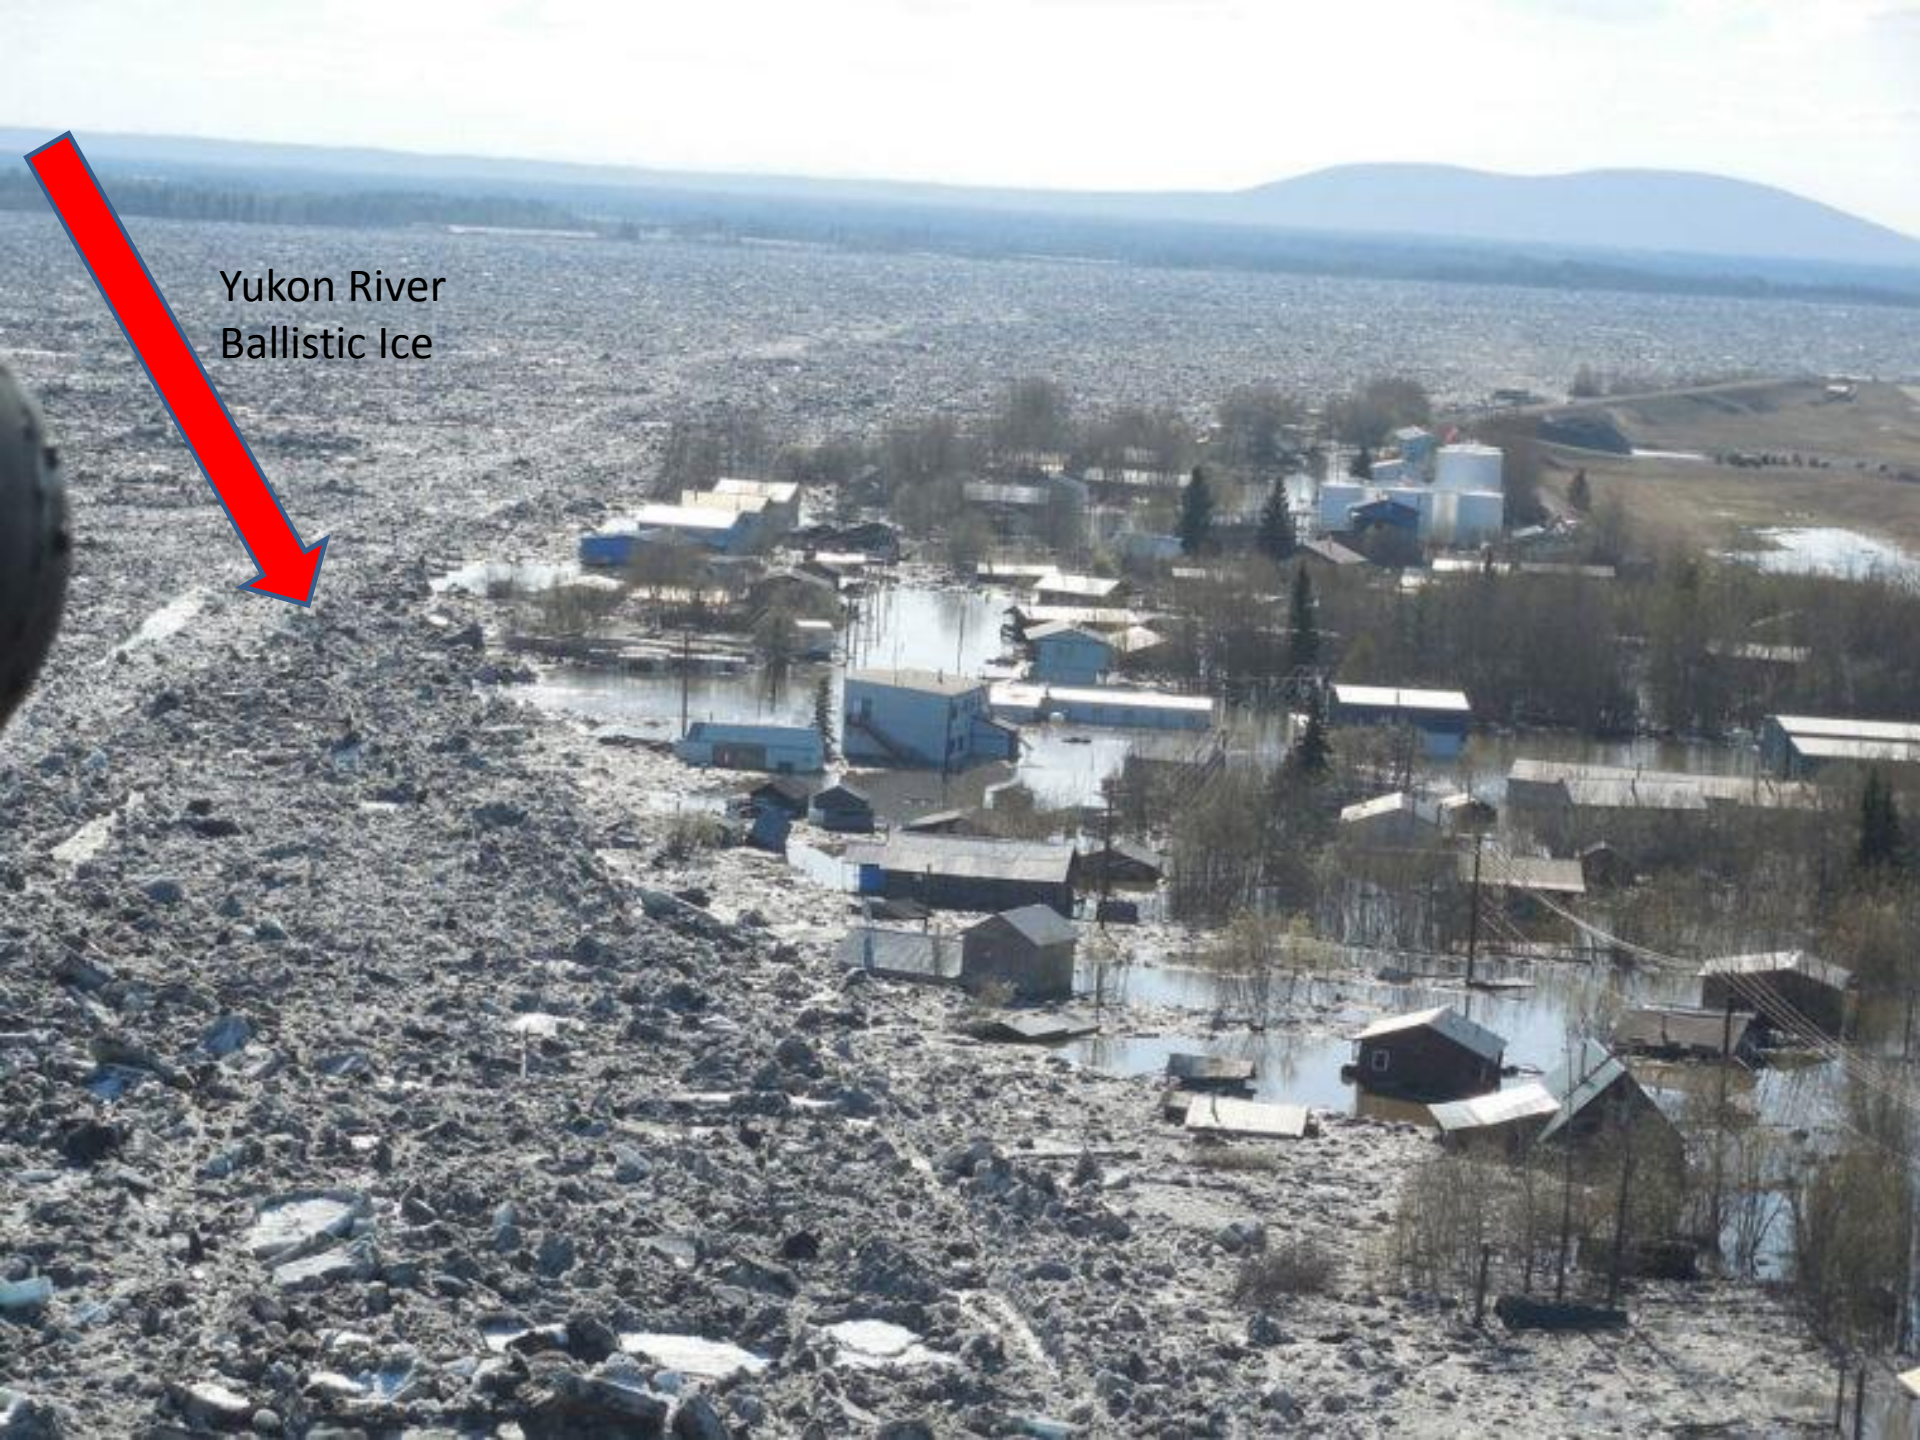
Yukon River  
Ballistic Ice

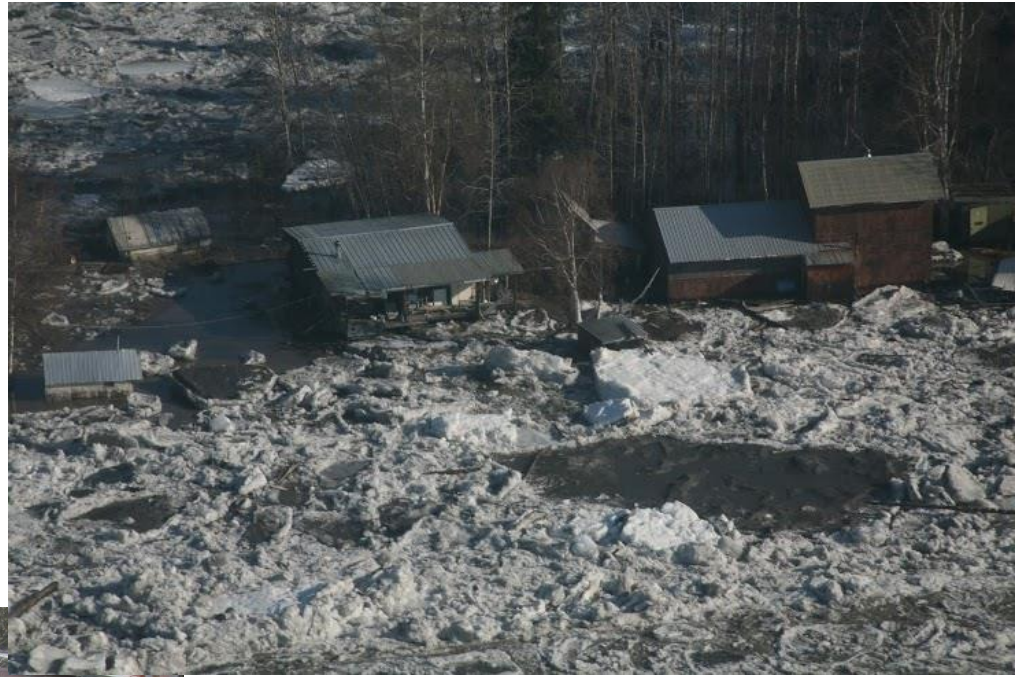
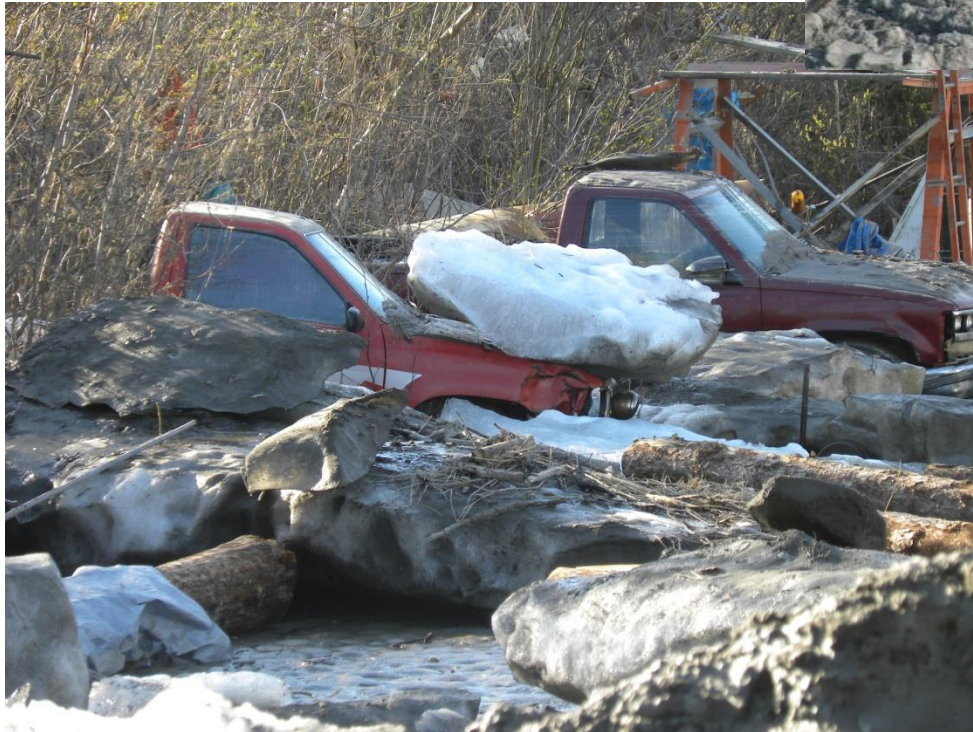
## Ballistic Ice Damage

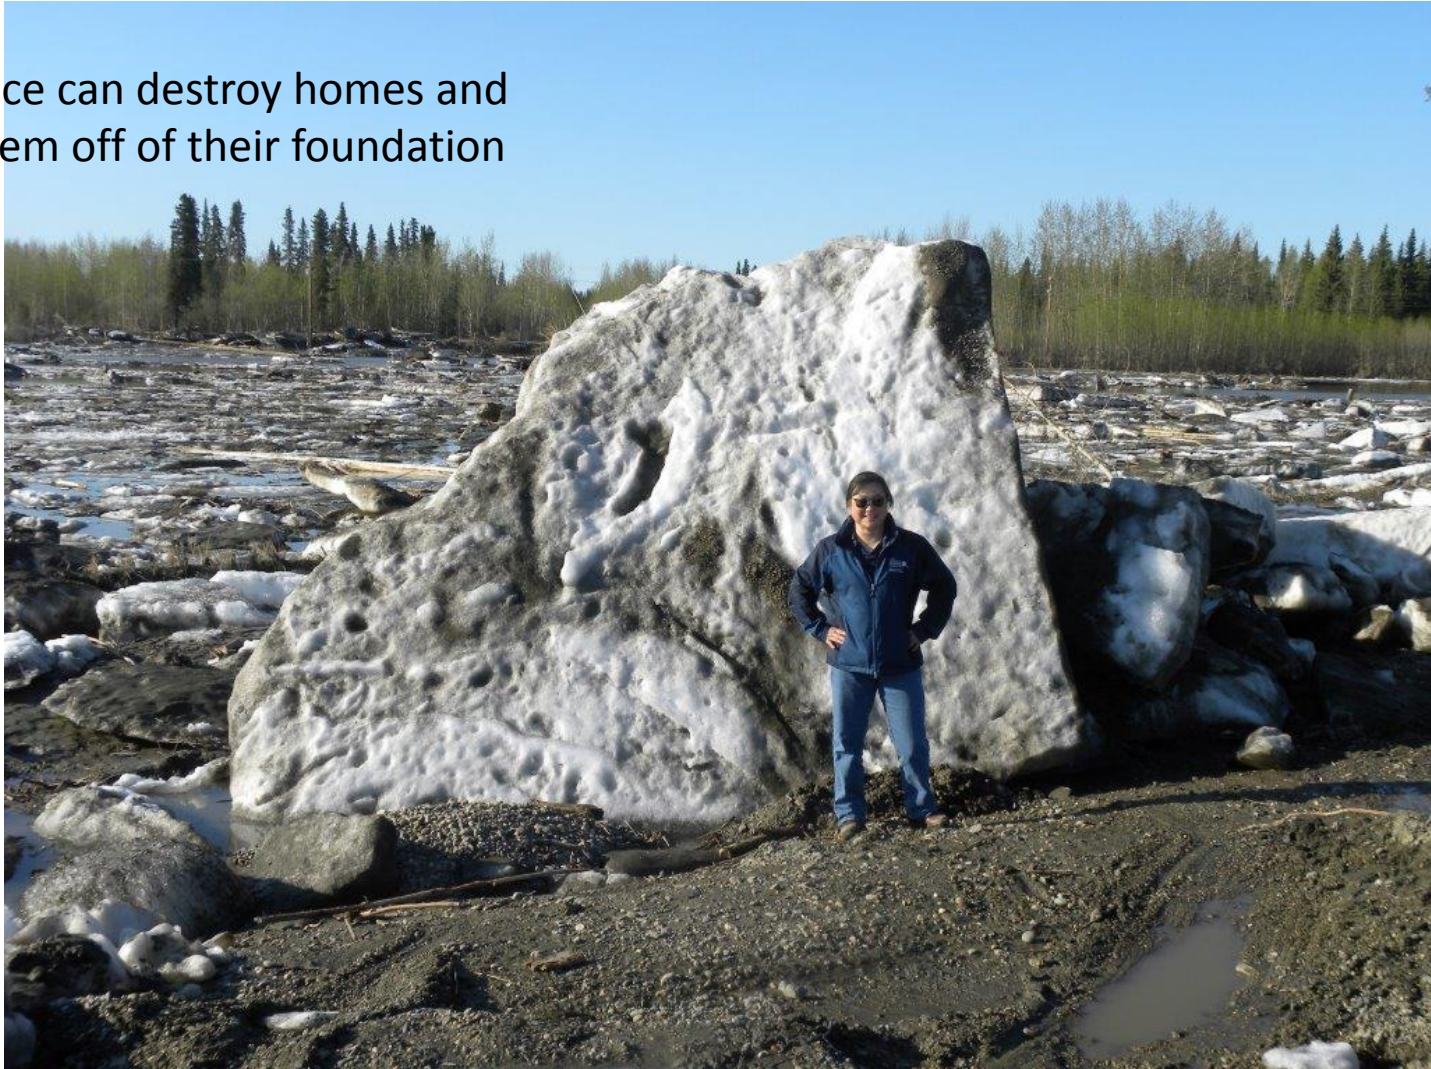
# Ballistic Ice from Galena Flood

Ballistic Ice can destroy homes and knock them off of their foundation
